STS-27R OV-104 ORBITER TPS DAMAGE REVIEW TEAM

SUMMARY REPORT

VOLUME I

FEBRUARY 1989

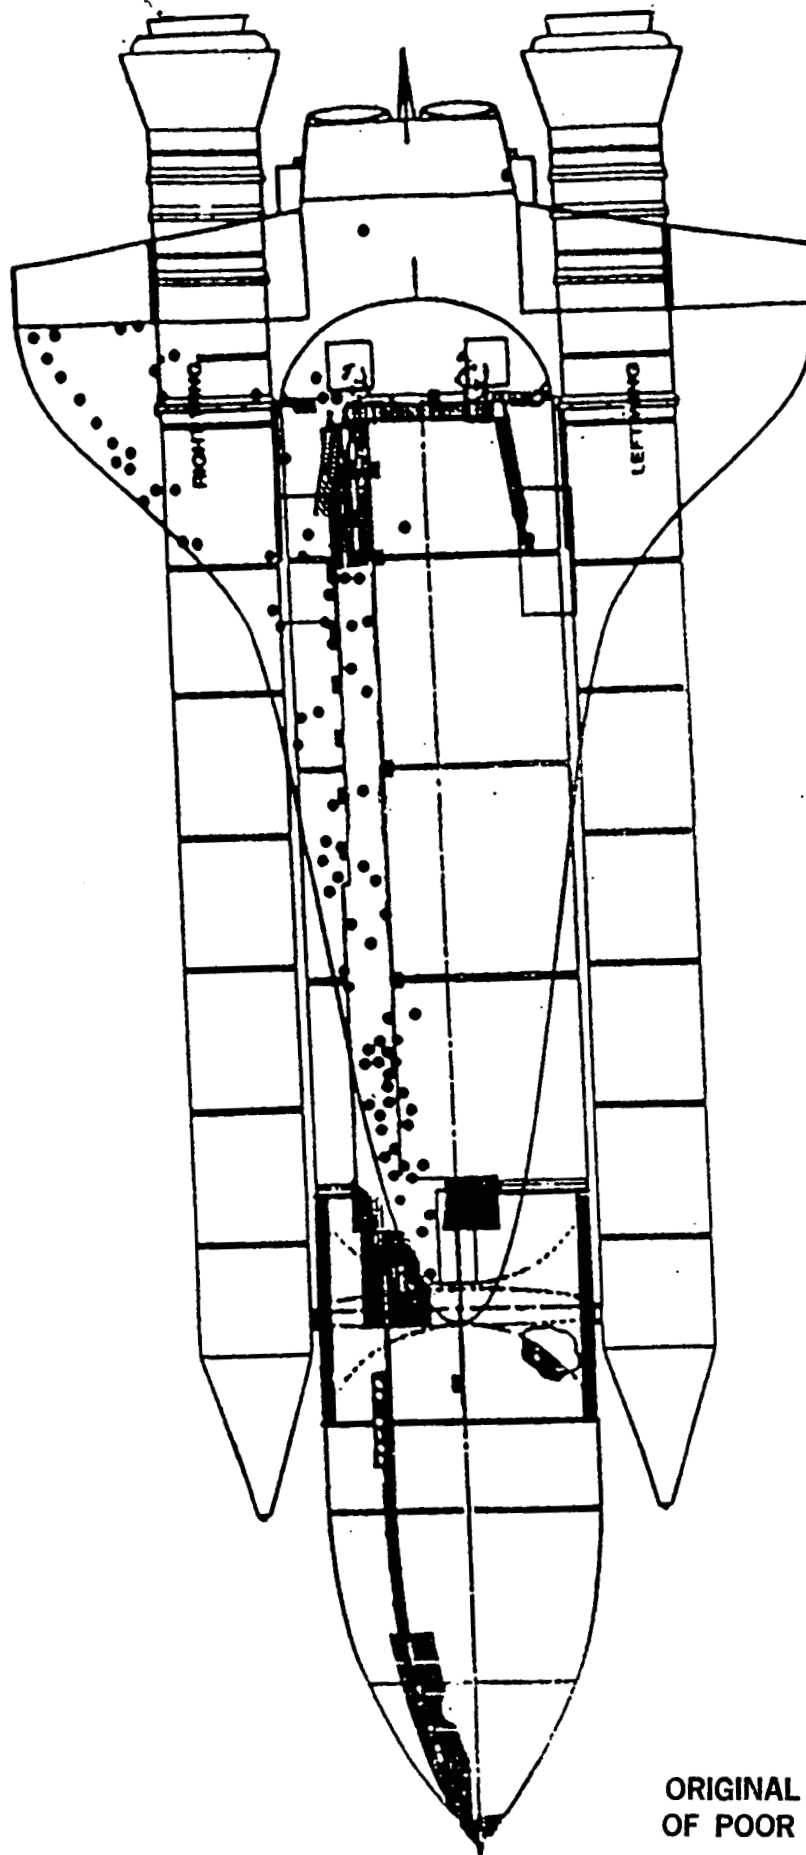
FIGURE 2-9
ET TPS LOCATION/DEFINITION RELATIVE TO ORBITER
LOWER SURFACE TILE DAMAGE PATTERN

The Orbiter damage sites and missing hardware are shown in Figures 2-8 and 2-9 depicting their relationship to the integrated Shuttle vehicle. Also, Figure 2-10 is included to depict the STS-27R major flight parameters.

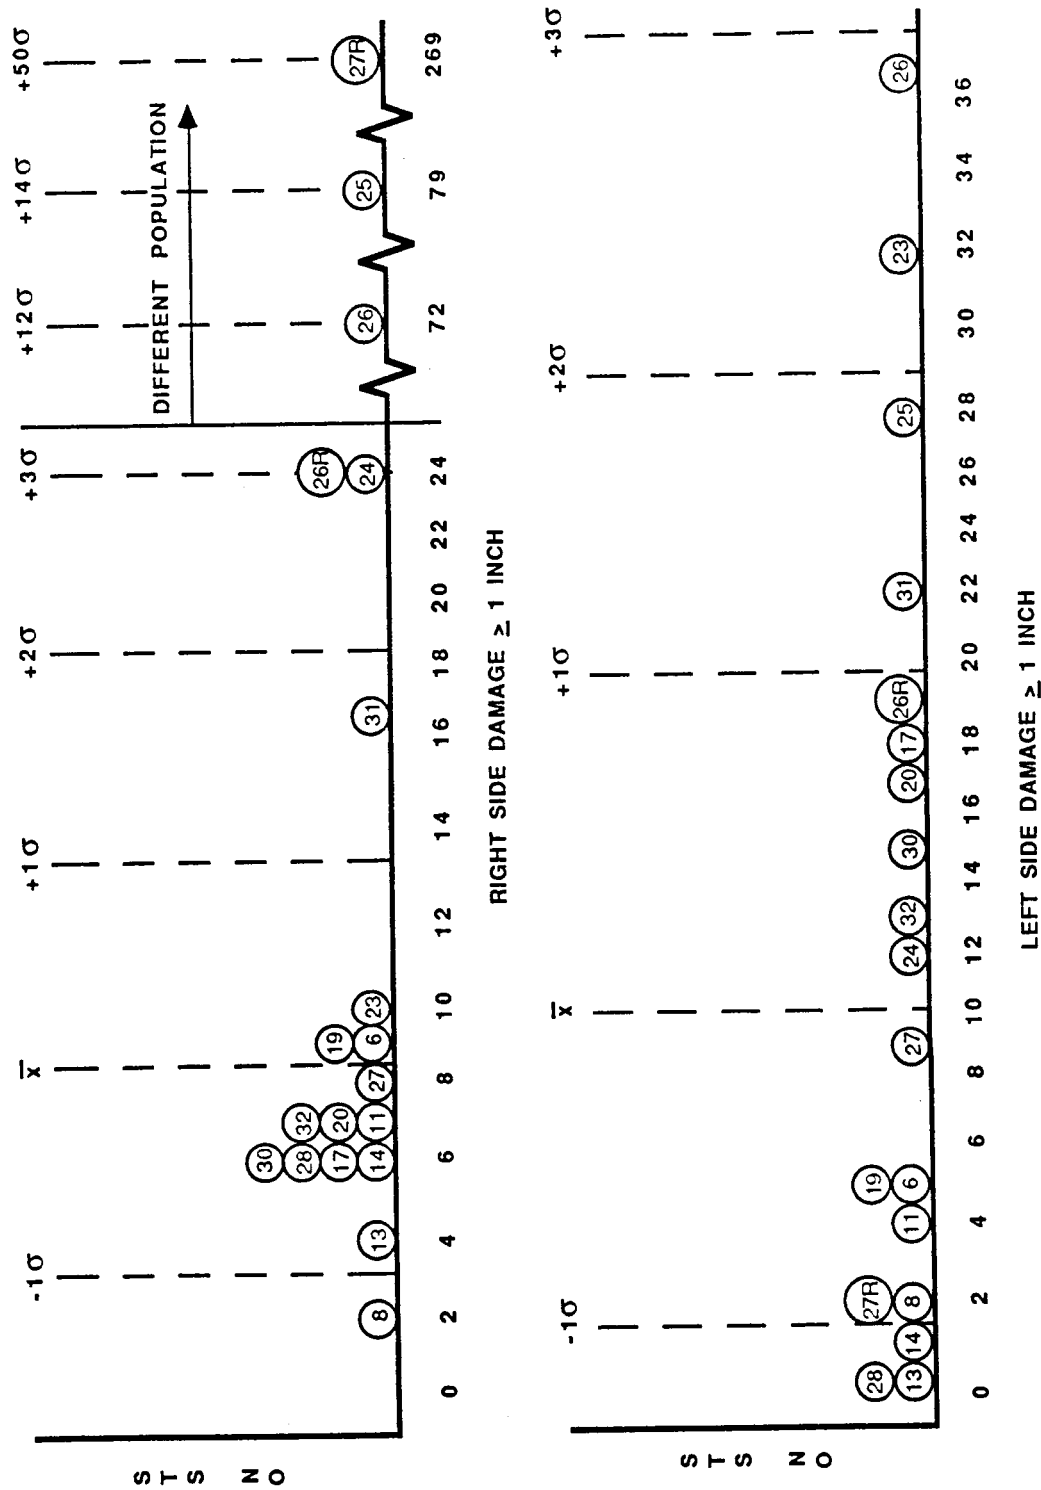
FIGURE 3-5
DATA REVIEW AND CORRELATION
ORBITER TPS DAMAGE REVIEW TEAM
STATISTICAL CORRELATION

The damage data base compiled to correlate previous tile damage, paragraph 3.1 above, was utilized to determine if STS-27R was within the prior damage population extremes. This statistical comparison used the damage attribute where any dimension is greater than one inch and was performed for both the Orbiter left and right sides. (See Figure 3-5.)

The total parameters compared with prior flights are shown in Table 3-1 and the data tables, and plots are contained in Volume II of this report. The comparison revealed only a slight right side total damage site correlation with minimum Q Alpha, and some correlation between large tile damage sites and Beta at SRB separation. (See Figure 3-6.) Even though there appears to be a slight correlation between total damage sites and minimum Q Alpha, the same is not true for large damage sites. It is

therefore concluded that Q Alpha was not a potential cause for the STS-27R severe damage. It is further concluded that Beta was not related to the severe damage cause because it was well within design limits, and that if debris had been generated in the SRB separation flight regime, analysis shows that it could not have damaged the tiles.

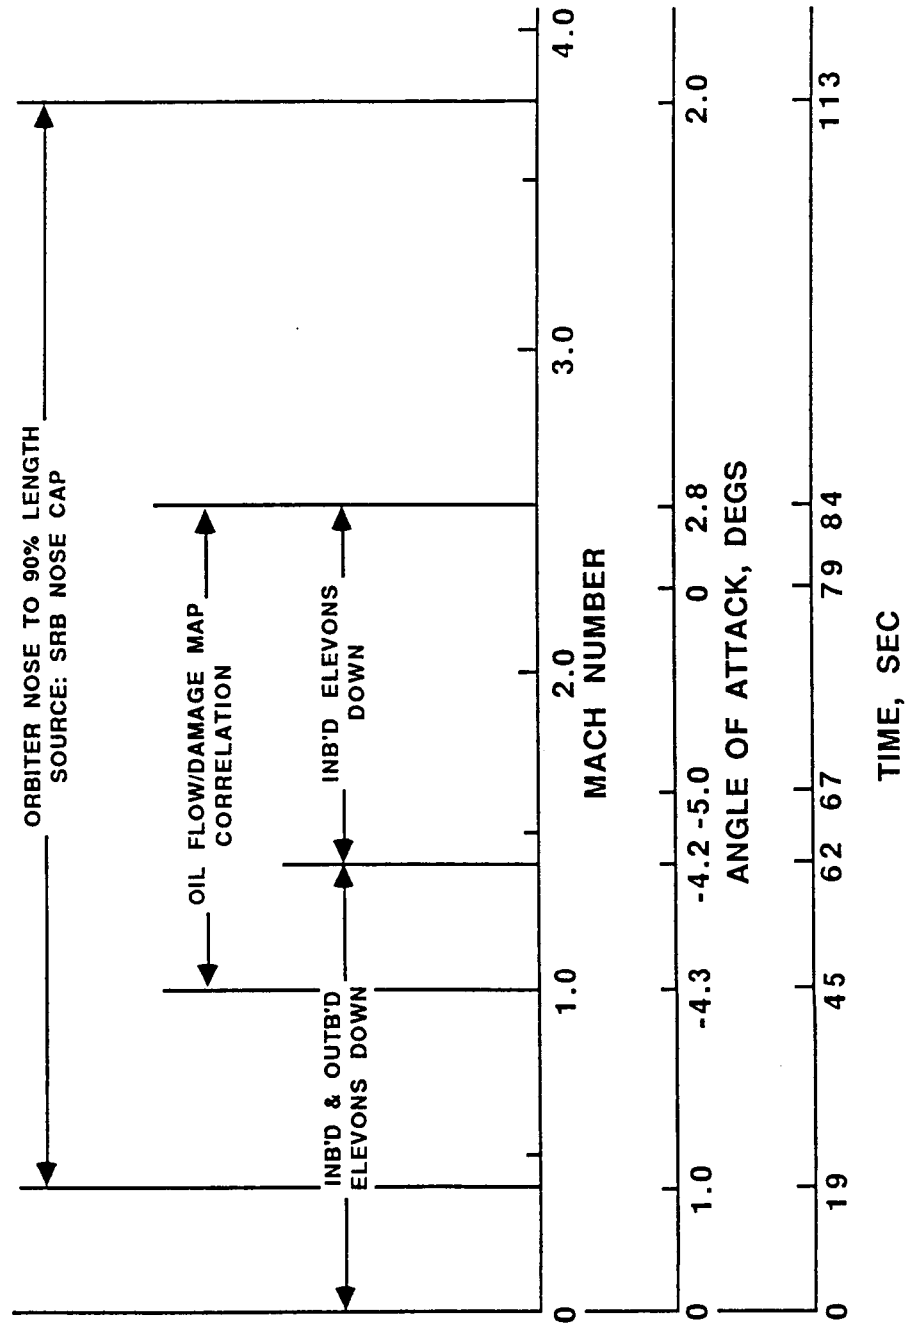
FIGURE 5-2
 ORBITER TPS DAMAGE REVIEW TEAM
 ASCENT DEBRIS TRAJECTORY SIMULATION

Figure 5-2 graphically depicts the assessment results leading to the most probable flight regime. Based on debris energy calculations versus tile damage energy thresholds, it was established that SRB Nose Cap debris can damage the Orbiter between Mach 0.4 and 3.75, and for ET Nose Cap debris between Mach 0.4 and 2.5. It is also shown that between Mach 1.0 and 2.5, the STS oil flow results correlate well with the Orbiter damage pattern. Further, it reflects that the Orbiter inboard elevon moves to neutral (i.e., out of the direct flowfield) at Mach 2.5. Therefore, since elevon damage history (Figure 5-3) shows damage on all flights prior to STS-27R, it is apparent that the STS-27R damaging debris event occurred after Mach 2.5.

It was noted from parametric debris transport analyses that the Orbiter tile damage probability increases substantially for positive vehicle angles of attack. Figure 5-2 also shows this condition exists after Mach 2.25. It is therefore concluded that the most likely flight regime where the STS-27R damage occurred is in the Mach 2.5 flight regime.

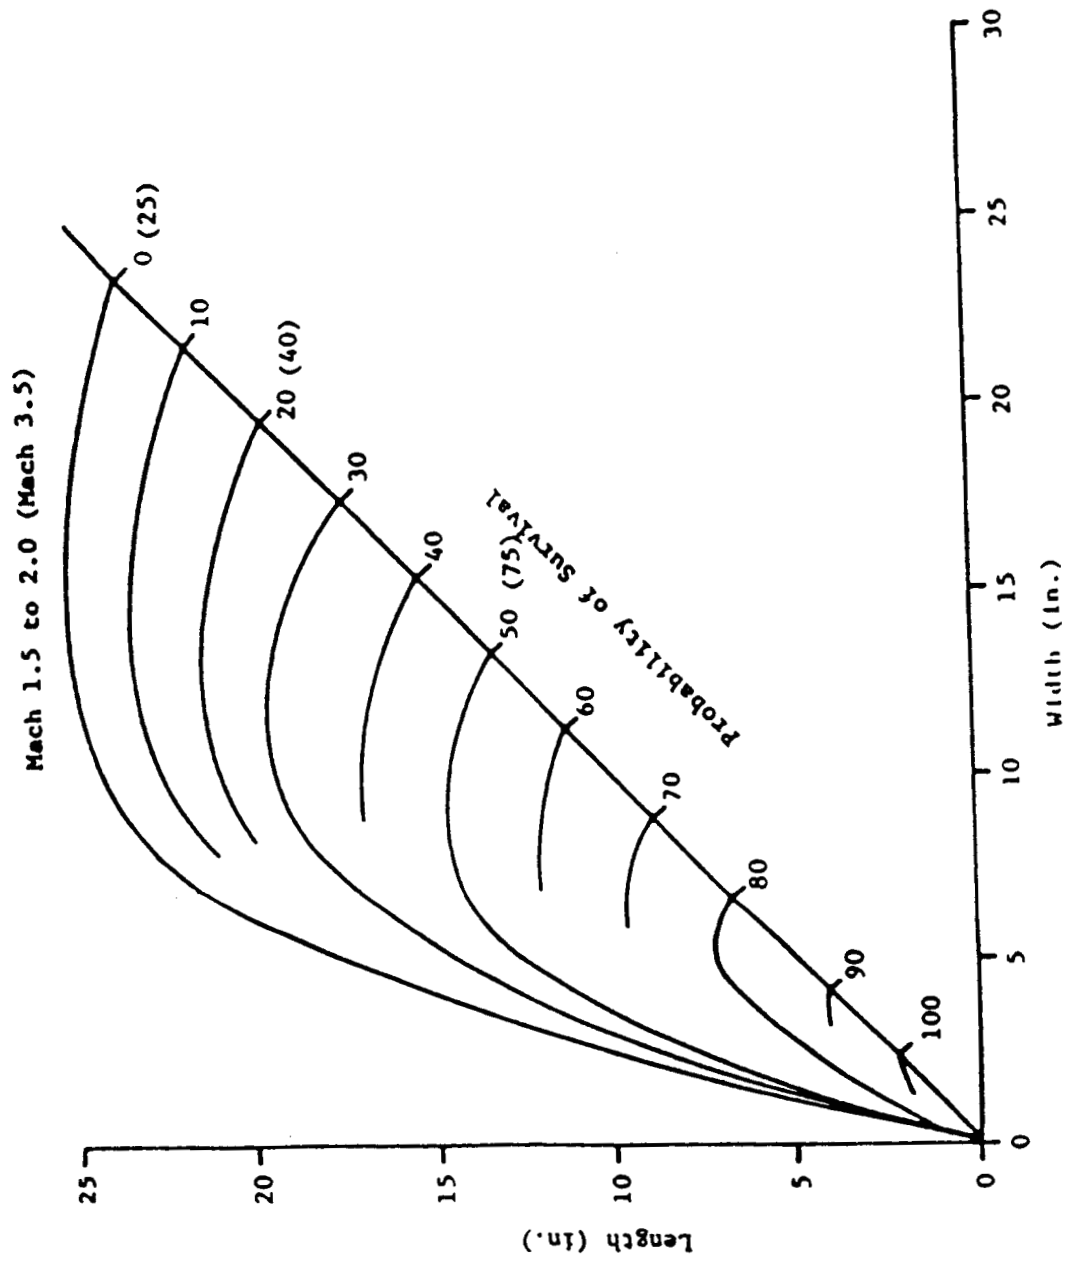
FIGURE 5-4
 ESTIMATED PROBABILITY OF MSA-1 DEBRIS SURVIVAL
 THROUGH ORBITER NOSE SHOCK

Debris passing through the shock wave is exposed to the two separate forces, which produce uneven loading or moments about the debris center of gravity (CG). Bending moments about the debris CG were calculated using a distributed lump mass approach. If the bending stresses were greater than 50 percent of the allowable MSA-1 tensile strength, a failure was assumed. The survival of each debris size for a given orientation was calculated using the methodology described above. The survival probability was calculated for each debris size as a function of pitch (0-90°) and roll (0-90°) combinations. Figure 5-4 presents the debris survival probability results versus debris planform size. It is noted from these data that a piece of MSA-1 .25 x 5 x 10 inches has a 70 percent probability of surviving transition through the Orbiter nose shock. Therefore, it is considered reasonable that this size debris could move from the SRB nose area to the Orbiter damage site without losing its structural integrity.

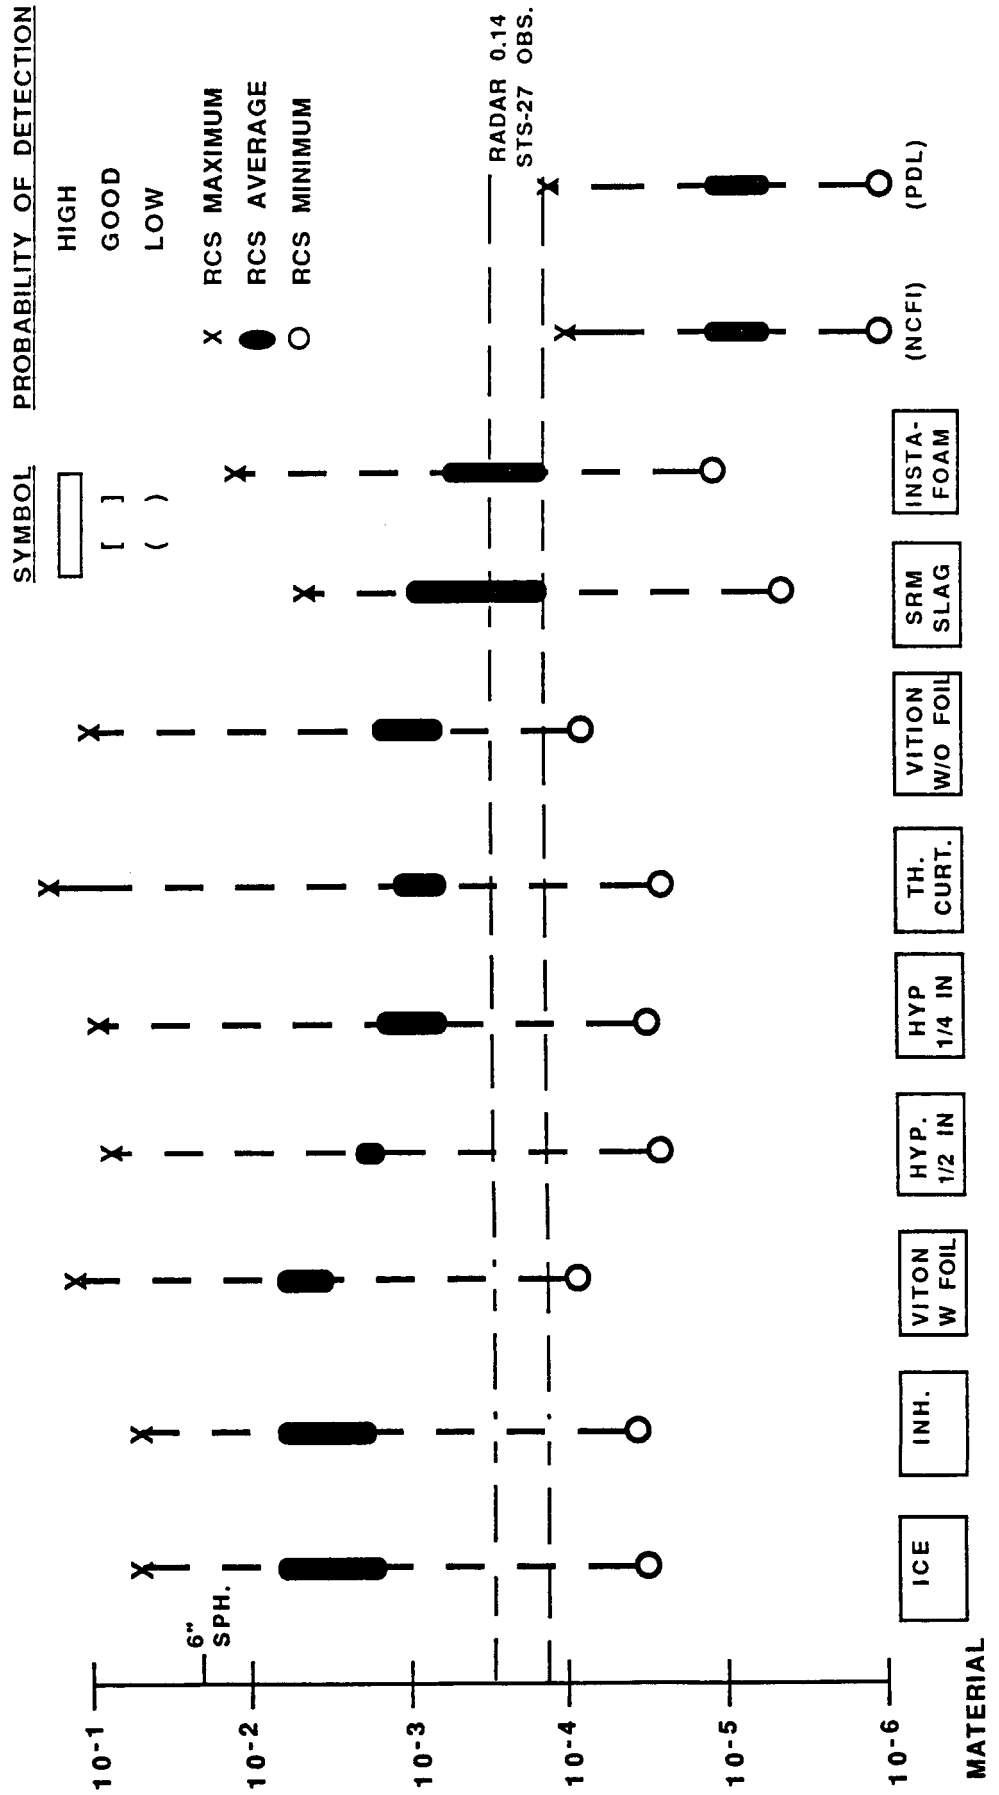
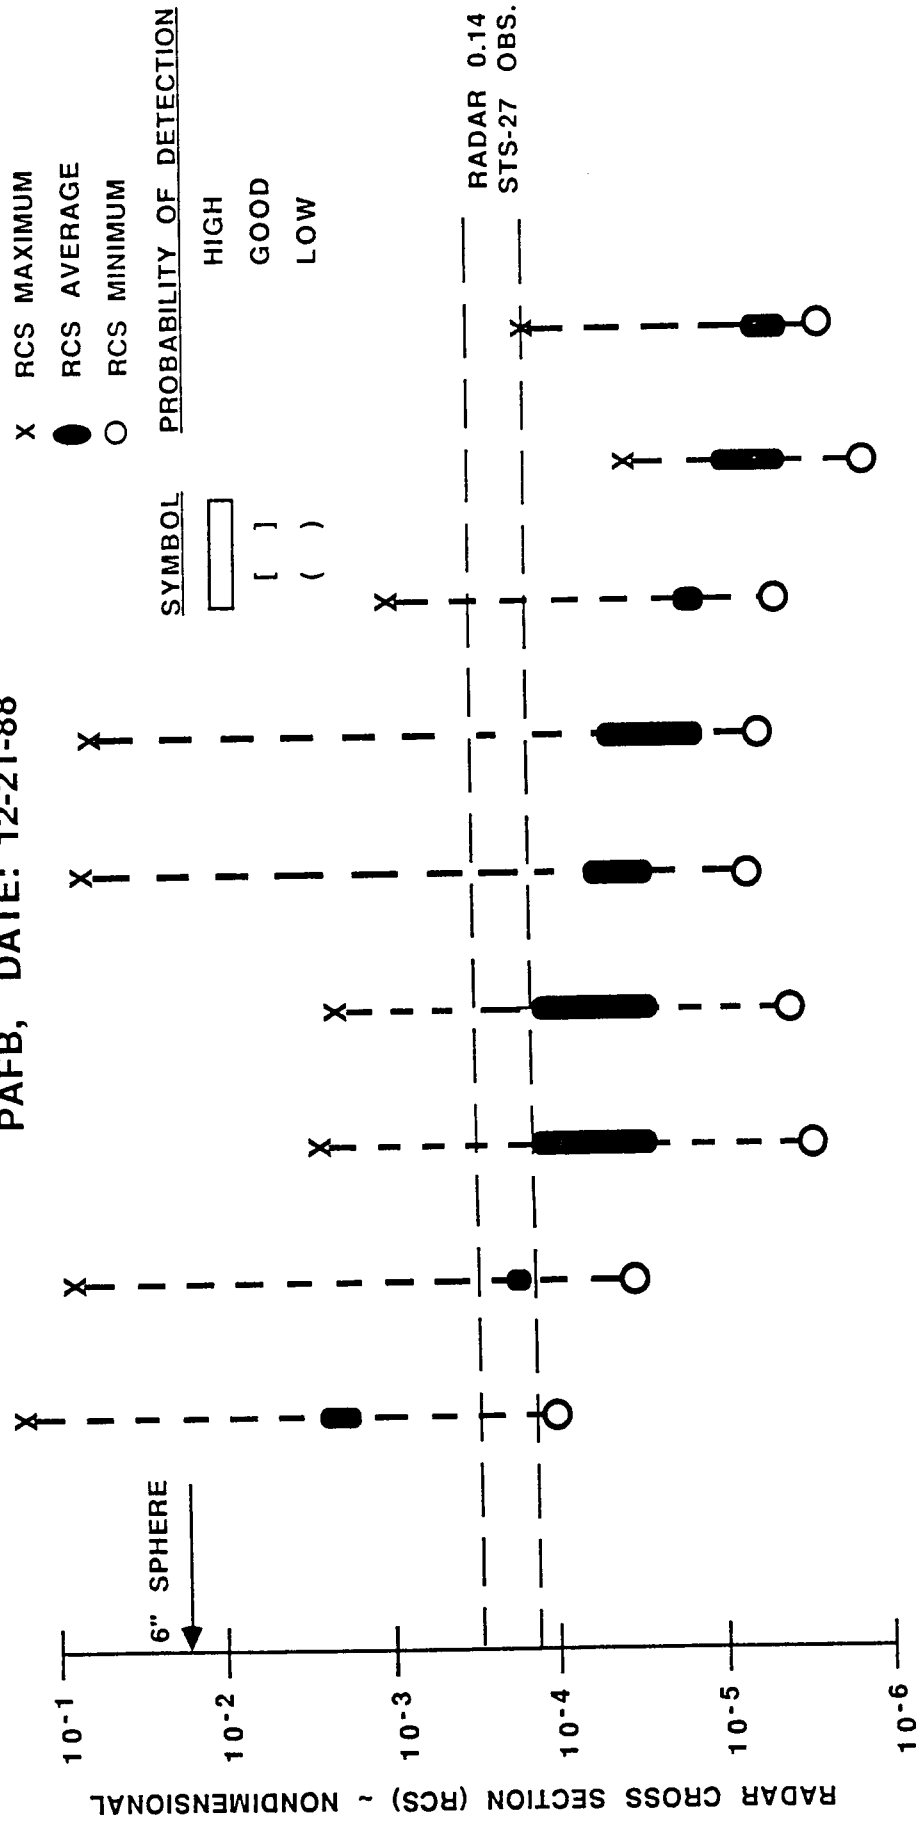
FIGURE 5-5 ORBITER TPS DAMAGE REVIEW TEAM C-BAND RADAR MATERIALS RELECTIVITY TEST

Table 5-3 lists the STS debris samples, their sources, and sizes provided for C-band characterization. Figure 5-5 presents signal strength characterization for 20 of the noted samples overlaid with the C-band Radar signal strength range for the STS-27R observed objects. The various debris types have been annotated to present a qualitative probability-of-detection (high, good, low). It was determined that four of the 20 samples tested, at the size tested, could not have been the STS-27R objects. Any of the remaining samples could potentially have been the source. Closer discrimination could not be made because the object signal returns were so faint.

The overall C-band observations significance was established, based primarily on the conclusions reached in Section 5.2, Debris Trajectory Analysis/Damage Flight Regime. Because the potential for damaging the Orbiter tiles by the suspected SRB or ET debris sources diminishes rapidly beyond the Mach 3.8 timeframe (Figure 5-2), it is not likely that the several unidentified C-band objects which were observed subsequent to SRB separation (T + 141 to 169 seconds) contributed to the STS-27R Orbiter tile damage. Although the single object observed at T + 53.5 seconds is in flight regime of potential damage, it is not consistent with the Mach 2.5 most probable flight regime, in particular, the no-elevon-damage consideration.
